Manhole Inspection Summary

Manhole # S49AA_029MH

Insp Date: **2/12/09 9:01 AM**

Location Address: **601 LUZERNE ST** Cross Street: **MCELDERRY ST**

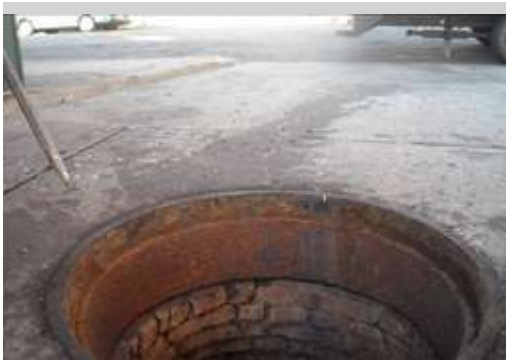
Miscellaneous

EVIDENCE OF INFLOW DUE TO SHEETING

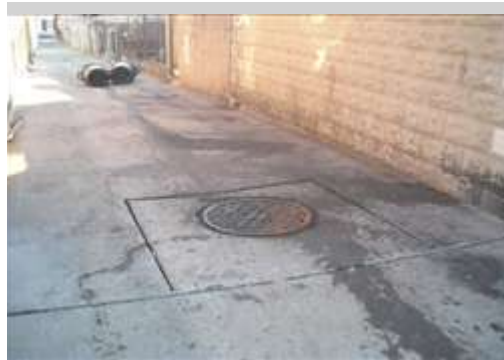
Miscellaneous

REPLACED WITH A NEW LID BY REI

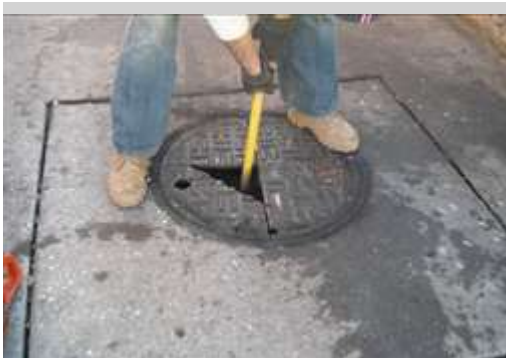
Miscellaneous

Manhole Type: **Terminal** Location: **Alley** Ground Conditions: **Dry**
☐ Prev. Rehab Weather: **Dry** Subject To Ponding: **Sheeting**
Comments **OPENED BY CUTTING ACROSS LID IN 3 DIRECTIONS, THEN USING 16 LB SLEDGE TO BREAK OPEN. REPLACED LID. MANHOLE FILLED WITH MUDDY DEBRIS. INSPECTION COMPLETED.**

SAW CUT AND SLEDGE TO OPEN COVER

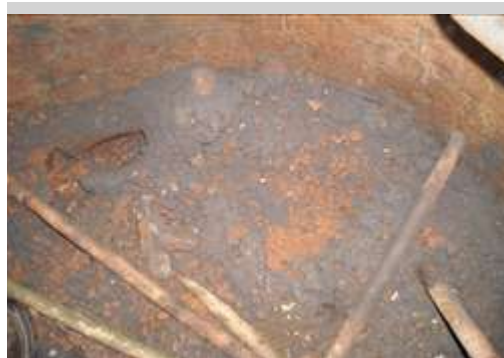
Defect 4

Channel Material: **Unknown** ☐ Parged
Channel Exposure: **Fully Open** Junc Dist: **0** nearest .5 ft. Azimuth: **0**
Condition: ☐ Sound ☐ Cracked ☐ Root Intrusion ☐ Deteriorated ☐ Leaks ☒ Debris

CHANNEL DEBRIS

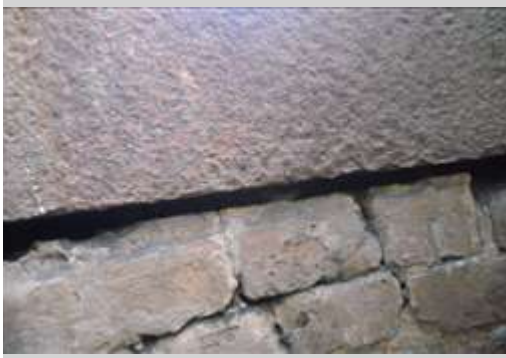
Defect 3

Corbel Material: **Brick** ☐ Parged Type: **Concentric/Eccentric**
Condition: ☐ Sound ☐ Cracked ☐ Root Intrusion ☒ Loose Brick ☒ Deteriorated
Infiltration: ☒ None ☐ Joint ☐ Cracks ☐ Mortar ☐ Roots ☐ Wall

CORBEL HAS LOOSE BRICK AND IS DETERIORATED

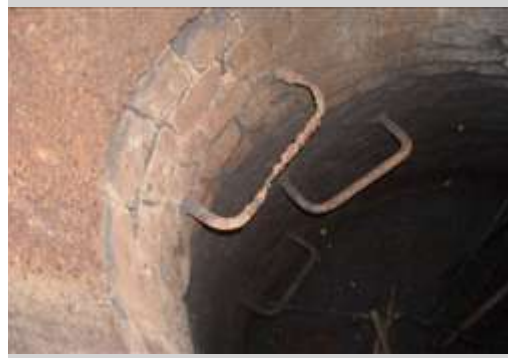
Defect 2

Steps Count: **3** Missing: **0** ☒ Corroded

STEPS CORRODED

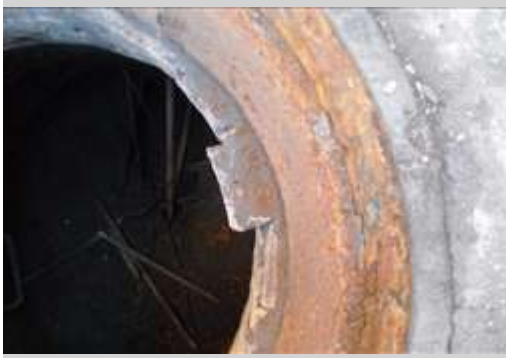
Defect 1

Frame Offset: **2** (in.) Condition: ☒ Sound ☐ Cracked ☐ Leaks

FRAME OFFSET 2"

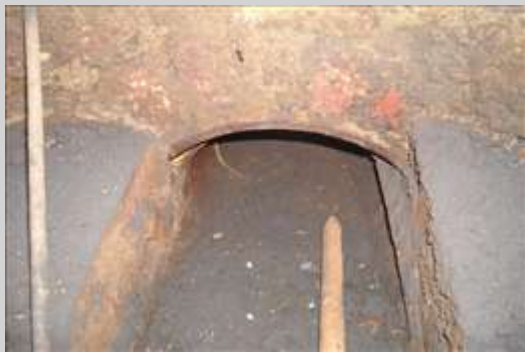
12 O'Clock Outflow

Deposits: ☐ None ☒ **Mud** ☐ Sludge ☐ Debris ☐ Grease

Silt Depth: **3** (in.) Deposits Extent: **Medium**
